**High Performance** Retrofit Yields Lower Operating Costs and Reduced Energy Consumption

# Tremco Headquarters

*Transforming a 40 year old building into a sustainable showcase*

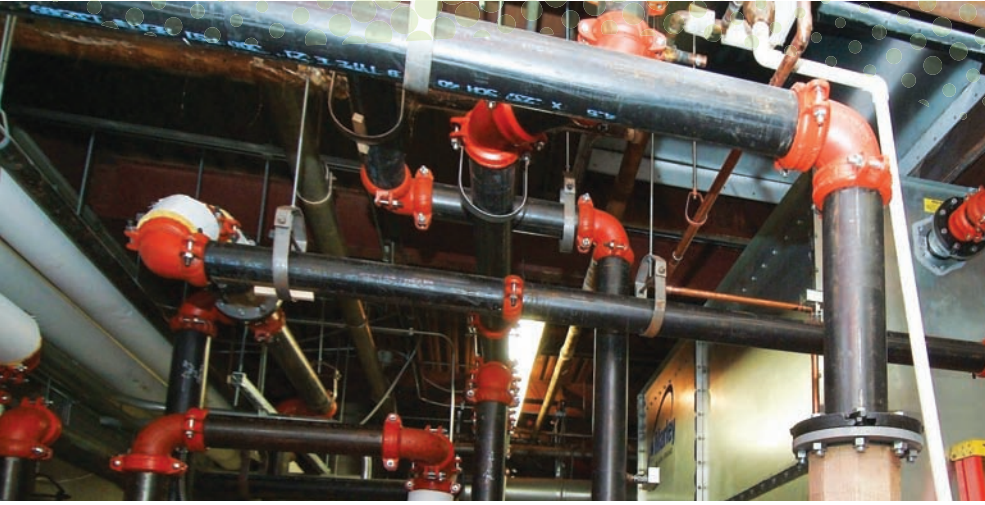
**HVAC HEATING SYSTEM** Two variable speed heating pumps were installed for more efficient operation. The piping system of the existing boilers was modified to achieve variable hot water flow. The entire perimeter radiation system was removed as a result of the increased performance of the building envelope.

**HVAC COOLING SYSTEM** The cooling system received an overhaul with the installation of a new, variable speed, dual cell cooling tower; two new variable speed chillers; and new, variable flow pumping systems. This equipment allows for greater energy efficiency by modulating flow and capacity and is precisely matched to the building's new cooling requirements.

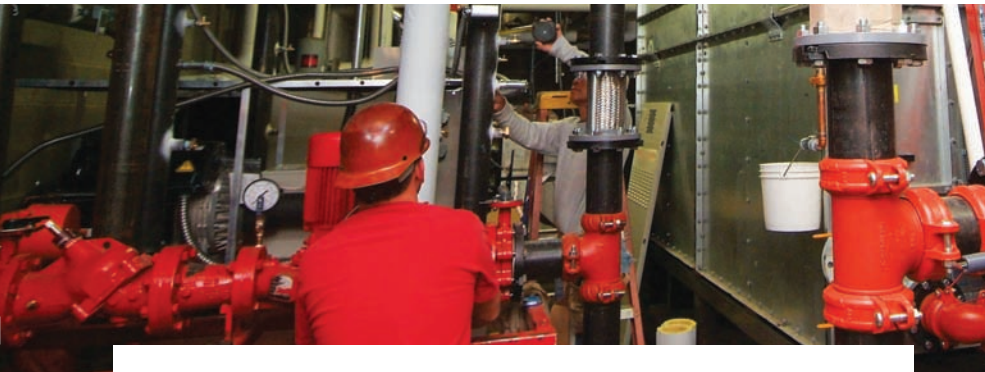
**HVAC AIR DISTRIBUTION** Distribution system components were converted to variable flow for more efficient operation. An energy recovery ventilator, communication network and occupancy sensors were also installed to meet mandatory energy requirements and improve operational efficiency.

**HVAC CONTROL SYSTEM** A facility-wide Building Automation System that incorporates "open protocol" communications controls and monitors all HVAC, lighting and renewable energy systems was installed. "Revenue Grade" submetering is utilized to monitor the energy contributions of the renewable energy resources.

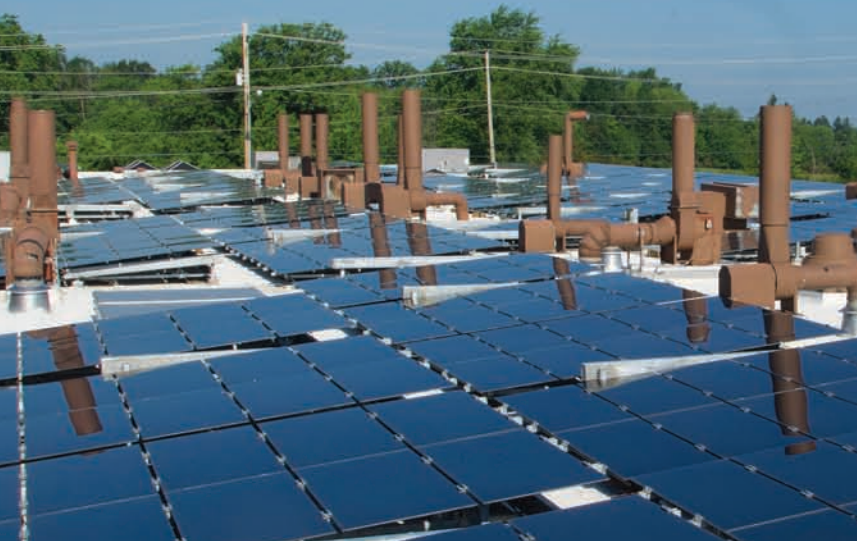
**PHOTOVOLTAIC** Two solar arrays were installed, one on the roof of the south building and the other atop the new carport, and are expected to generate a combined 100,000 kWh annually. The carport includes four solar-powered electric vehicle charging stations, with room for additional stations, and funnels power to the headquarters building when the charging stations are not in use.

**WIND TURBINE** Up to 6,000 kWh per year is expected from the wind turbine installed on the campus. The turbine has an instantaneous power rating of 1.8 kW at winds of 25 mph.
