## Down in the Dumps? Not With This Green Fix!

BY JACK INNIS, CONTRIBUTING EDITOR  
PHOTOS COURTESY BRAZOS URETHANE, INC.

Apply bio-based coating system on 10 roofs at a community college in California

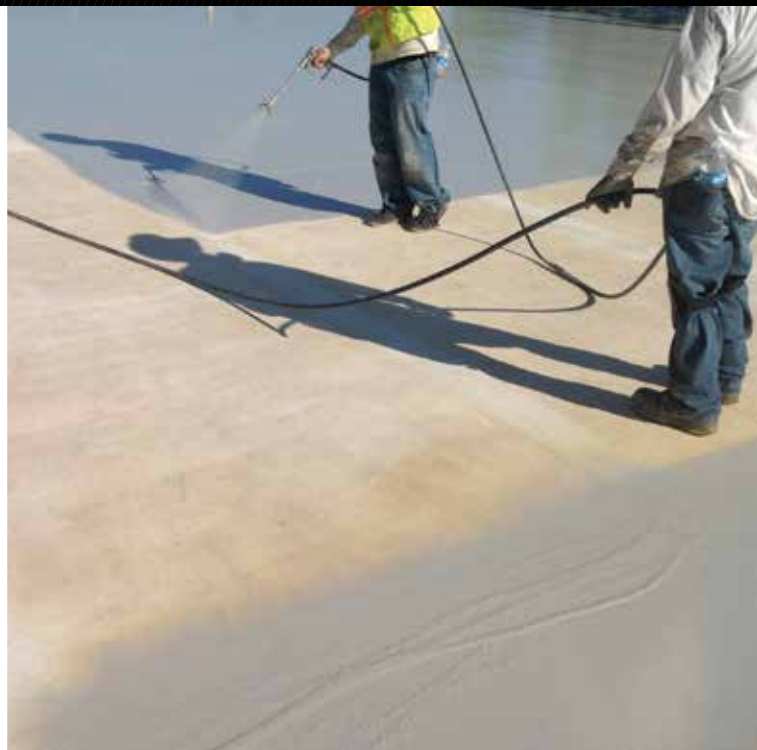
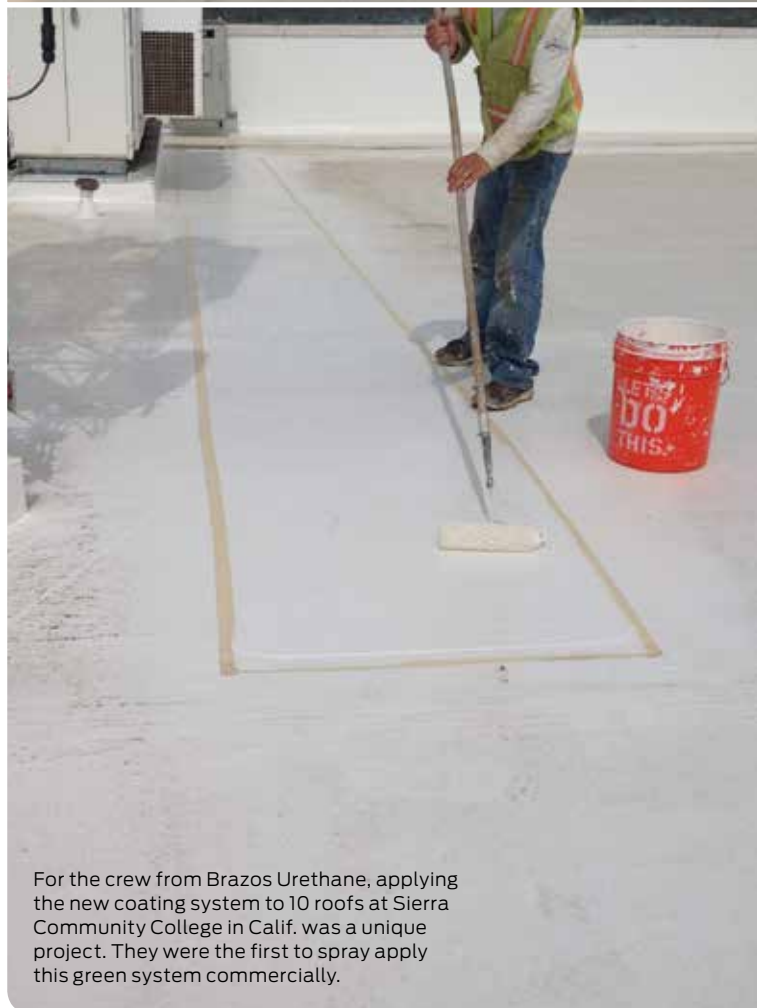
For the crew from Brazos Urethane, applying the new coating system to 10 roofs at Sierra Community College in Calif. was a unique project. They were the first to spray apply this green system commercially.

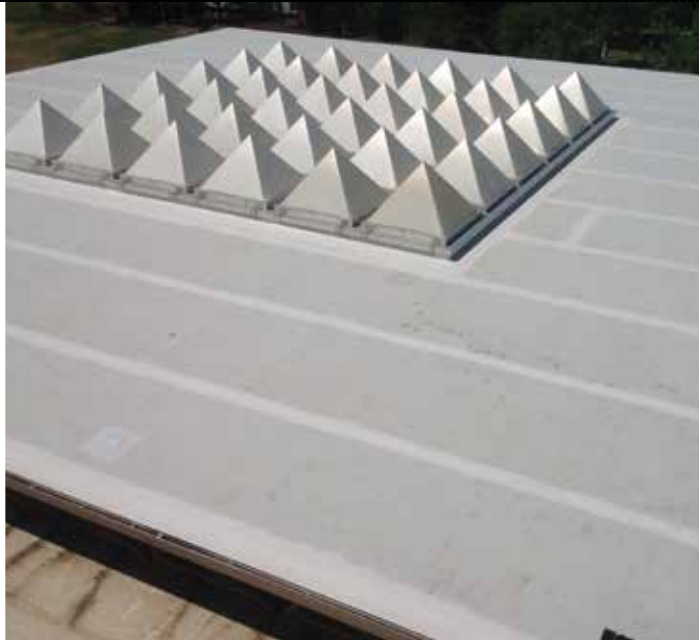
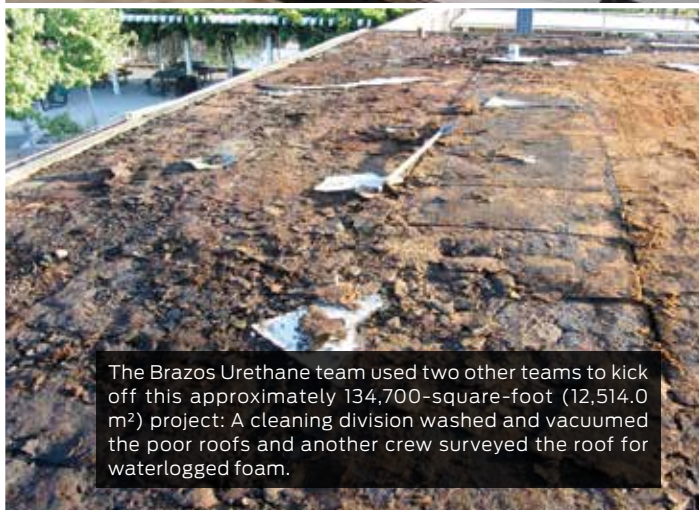
The Brazos Urethane team used two other teams to kick off this approximately 134,700-square-foot (12,514.0 m<sup>2</sup>) project: A cleaning division washed and vacuumed the poor roofs and another crew surveyed the roof for waterlogged foam.

California water and waste stream regulations are among the toughest in the country, and Rocklin’s Placer County is no exception. Most notably, allowing water from pressure washers to enter storm drains or sewer systems is prohibited. Thankfully, Tremco’s WTI RoofTec Roof Cleaning Division knows the ropes. Using a machine about the size and shape of a floor buffer, a two-man crew attacked the roofs with powerful, non-abrasive, rotating water jets. The dirt and spent water

were instantly captured by a vacuum system and sent to a collection tank for filtering. The Tremco crew then sprinkled the filtered water onto the campus landscape — all on the up and up. How’s that for recycling and reusing?

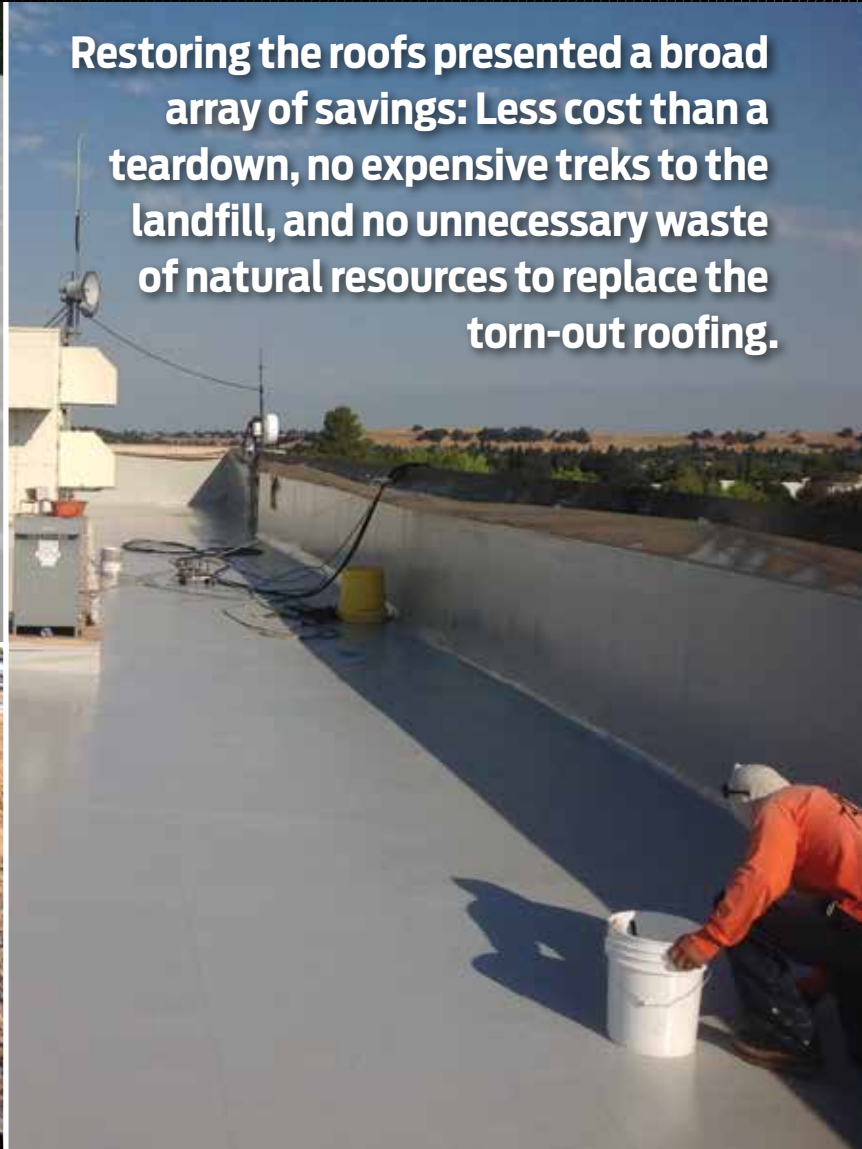
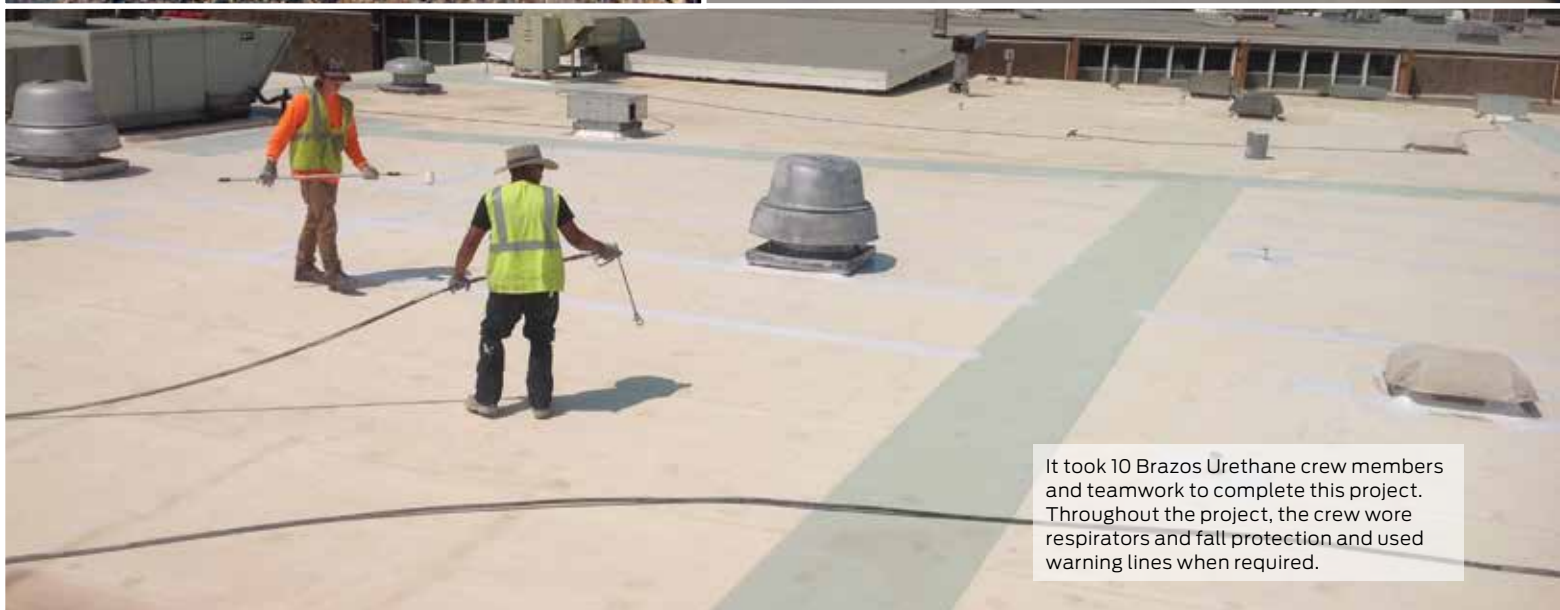
It took 10 Brazos Urethane crew members and teamwork to complete this project. Throughout the project, the crew wore respirators and fall protection and used warning lines when required.

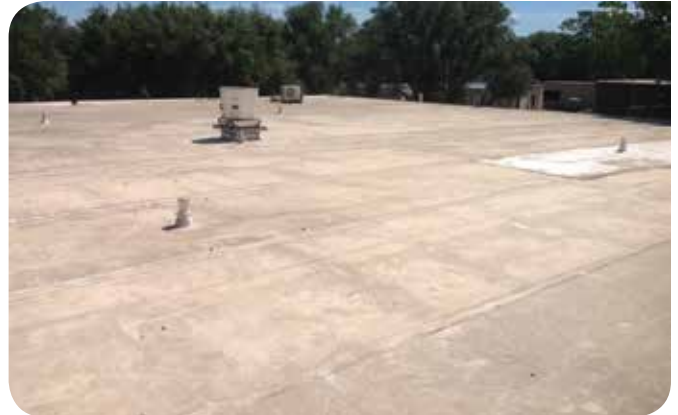
Once the waterlogged areas were identified, the Brazos Urethane crew replaced that foam and covered any exposed areas with fiberglass mat roof boards. The buildings were inhabited throughout the project.

Jobsite access was great. After coordinating parking lot closures with school facility management, the men backed their 24-foot (7.3 m) Ford F-650 and 26-foot (7.9 m) International 4900 box trucks right up to the buildings. First, the Brazos crewmen cut out soggy insulation panels and replaced them with 4-foot-by-8-foot (1.2 m x 2.4 m) sheets of 2-inch thick (5.1 cm) GAF foam board. They topped the repaired sections with ½-inch-thick (1.3 cm) DensDeck fiberglass mat board and sealed the newly created joints with Tremco SOLARGARD polyurethane seam sealer. But sealing didn't stop there.

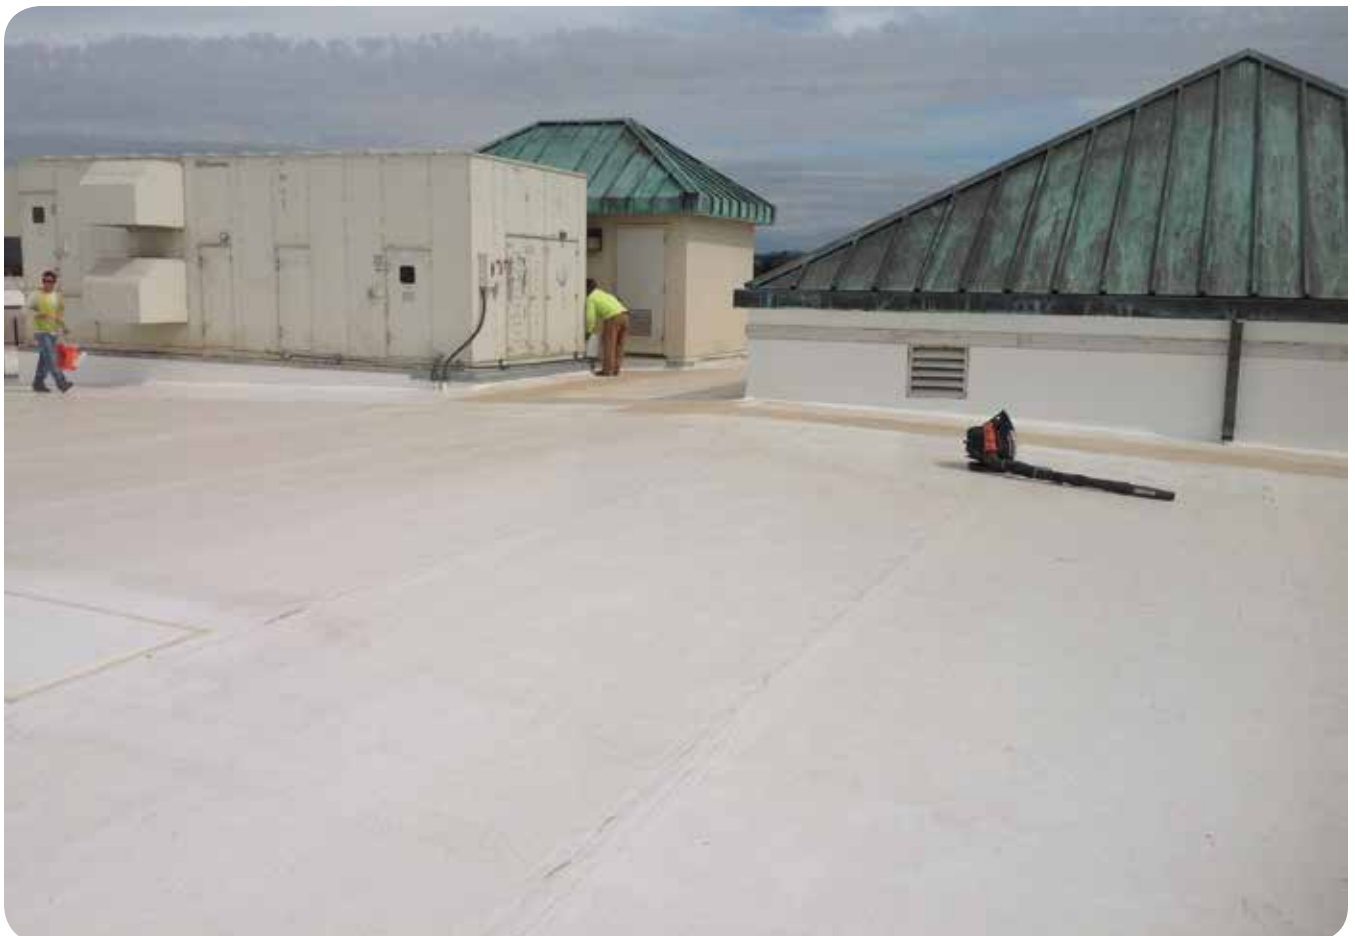
Around the seams, flashings, and seam laps, the crew installed a polyester fabric into the seam sealant. The fabric was PERMAFAB and the sealant was SOLARGARD, both from Tremco.

"We used 4- and 6-inch [10.2 cm and 15.2 cm] rollers with ¾-inch [1.0 cm] nap to spread seam sealer over pre-cut strips of Tremco PERMAFAB polyester fabric, maintaining 4-inch [10.2 cm] overlaps," said Brazos superintendent Victor Reyes. "We did the same on all flashings and on every existing membrane seam to create an additional line of defense against leaking."

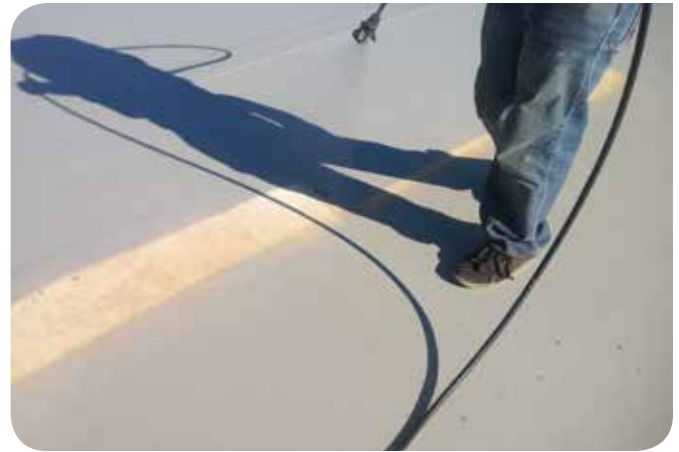
The crew primed the roofs with Tremco AlphaGuard, which was spray applied at ~1 mil (25.4 microns). That water-borne primer was the first step in this system, suggested by Brazos Urethane's Western Division Manager Craig Opel.

The crew then fired up their Graco 833 airless rig and sprayed a 1-mil (25.4 microns) approximate DFT single pass of Tremco AlphaGuard WB water-borne primer. Unlike the AlphaGuard basecoat and topcoat, the seam sealer and primer were not zero volatile organic compound (VOC). Therefore, the Brazos crew scheduled as much work as possible around classroom hours so students wouldn't be mumbling, "What's that smell?"

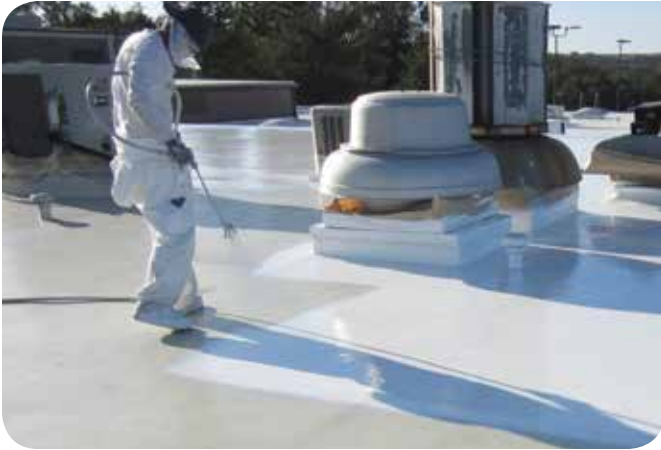
The second and third layers of coating were Tremco AlphaGuard polyurethane, applied at ~32 mils (812.8 microns) each. In addition to the bio-based system, the crew avoided landfill use and minimized volatile organic compounds (VOCs).

The Brazos crew felt great about addressing Sierra Community College's three main concerns. They had worked around a ban on pressure washers, figured out a way to avoid exposing students to unwanted odors, and were on track to finish on time. Like a well-oiled machine, they transitioned quickly to topcoat application. While crewmen in the box van switched from the AlphaGuard BIO basecoat to the AlphaGuard BIO topcoat, others cleaned the spray equipment with methyl ethyl ketone (MEK) solvent. The crew then fired up their Graco XP70 and began applying the 32-mil (812.8 microns) approximate DFT AlphaGuard BIO topcoat in a single pass.

"We applied the 32-mil [812.8 microns approximate DFT] basecoat in one pass," said Reyes. "The main challenge on both BIO coats was to make sure we stayed in contact with the guy in the box van watching the pumps. You can't stop spraying or the stuff sets up in the hose."

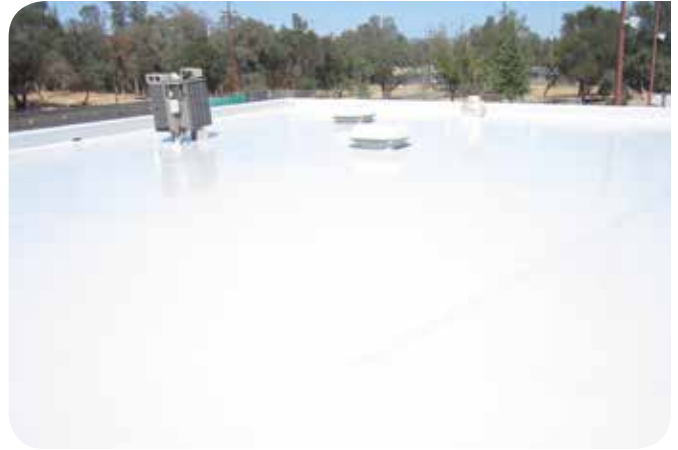
“We are extremely satisfied with the end result,” said Colin Irwin of the college. “One of my most important rules is that a contractor does what he says he’s going to do, and Brazos did so...”
