SAFETY SOLUTIONS PROJECT

CARTER MACHINERY CUSTOM SOLUTION

CARTER MACHINERY

PROBLEM: Unsafe access to perform HVAC maintenance

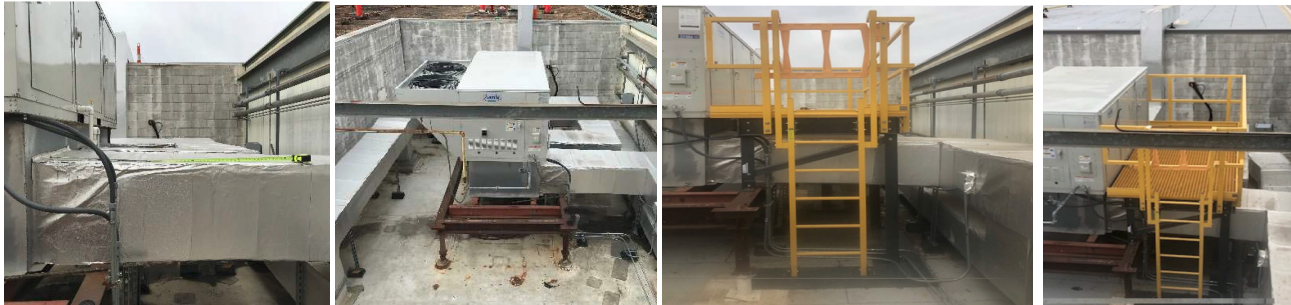
These photos show the extent of damage to the duct work

Accessing the HVAC system is difficult, and employees have to stand on the duct work to service it. This exposed the employees to a potential fall hazard greater than four feet and also damaged some of the duct runs.

Jim reached out to Josh Bonardi, the regional Safety Solutions Representative (SSR), “to find the best solution to safely access the HVAC unit. Through Josh’s experience, we were able to come up with an engineered platform that allows easy and safe access for my customer,” explained Jim. What they developed was a custom platform made of FRP (Fiberglass Reinforced Plastic) from our RPM sister company, Fibergate.

Josh and Jim also enlisted the services of our engineering partners LJB to ensure that not only was the new platform design structurally sound, but also the correct solution for the dilemma. LJB collaborated with Fibergate on the designs and with customer approval, the fully compliant platform was built. Upon arrival to the customer’s facility, the platform was installed by WTI in a matter of two (2) days at an approximate cost of \$18,000 for the full turn-key operation.

SAFETY MATERIALS INSTALLED: Custom platform created using Fibergate™ FRP material
