TREMLOCK NARROW BATTEN EAVE WITH GUTTER

DWG NO. NB-09

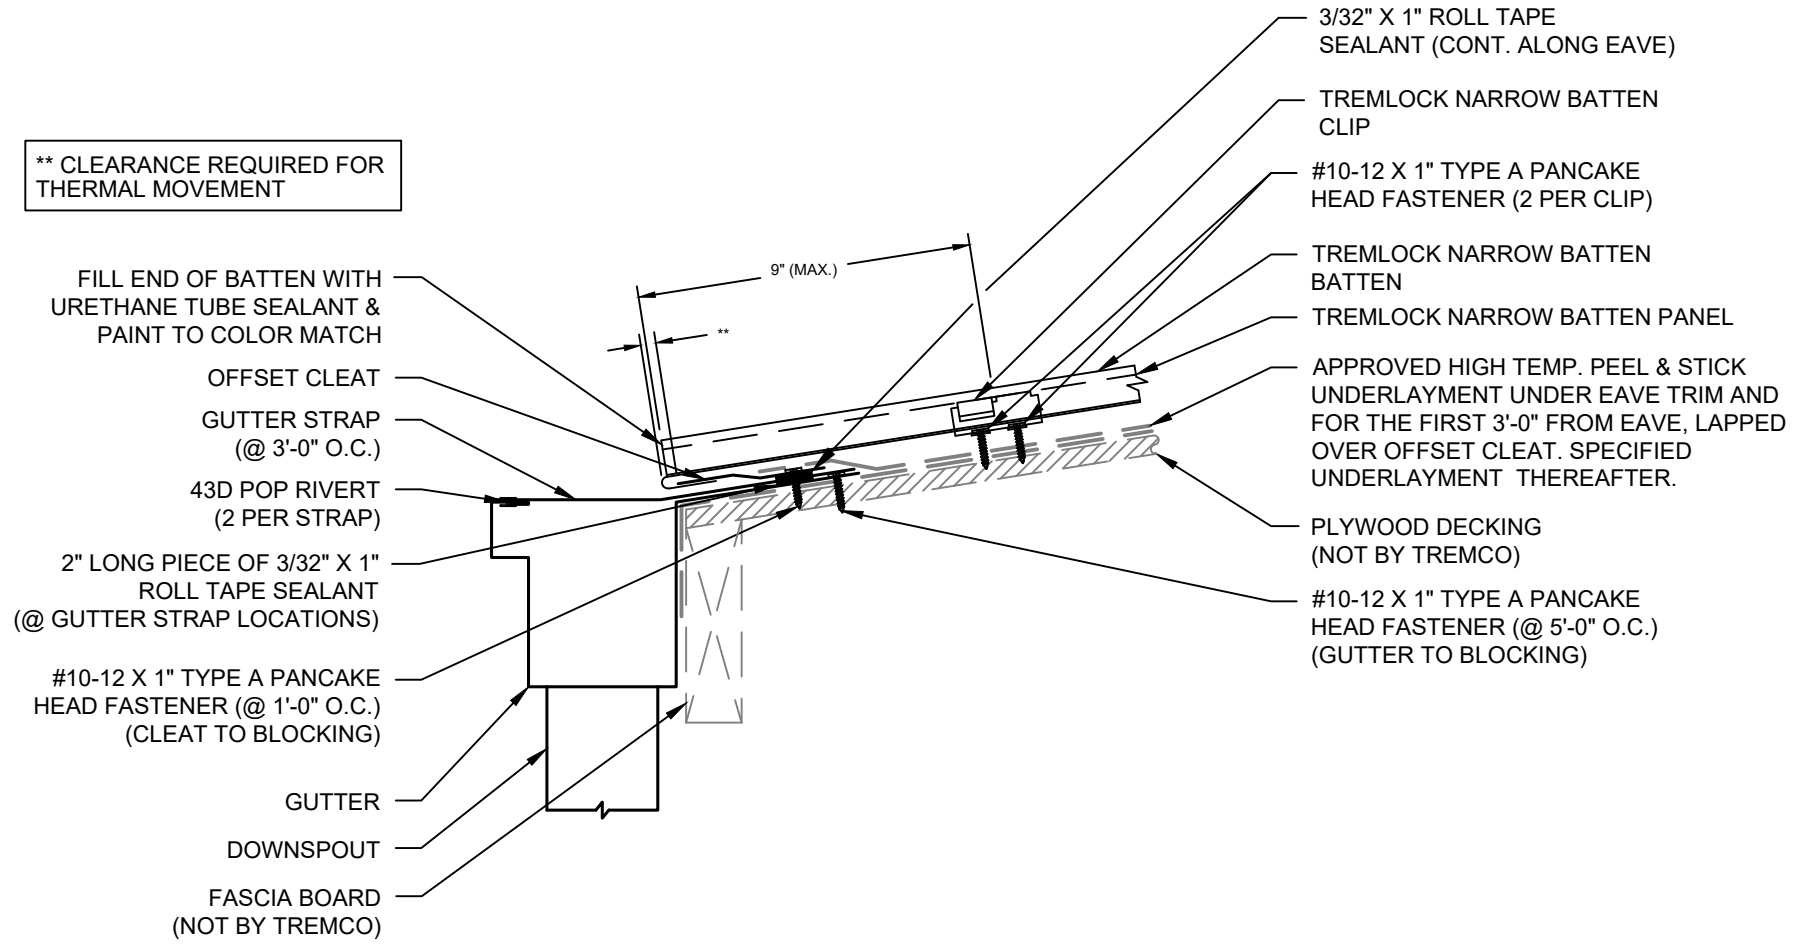
**** CLEARANCE REQUIRED FOR THERMAL MOVEMENT**

*NOTE: SLIDING SNOW AND ICE COULD CAUSE DAMAGE TO GUTTER SYSTEM.
